**Investigation of Coating Cracking and Fatigue
Strength of 7050-T74 Aluminum Alloy with Different
Anodize Coating Thicknesses**

Honors Thesis

The Ohio State University
Department of Mechanical Engineering

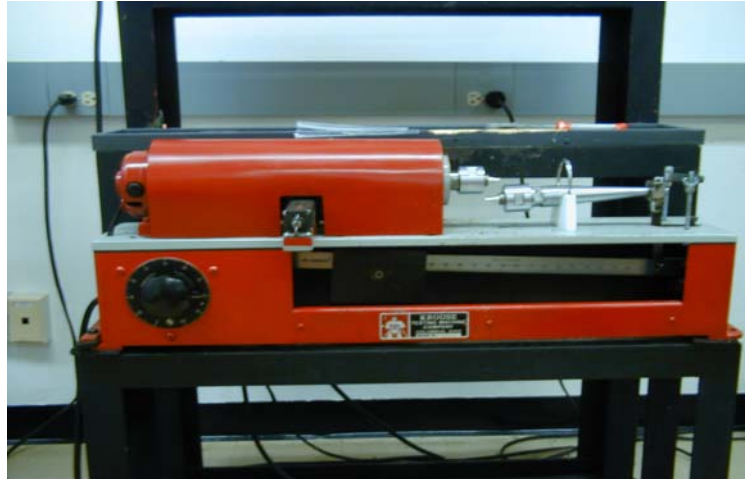
Figure 14: Photo showing Krouse 200 in-lb rotating cantilever beam machine

To experimentally investigate fatigue properties of 7050-T74 aluminum alloy, specimens were subjected to cyclic loading conditions to induce failure. Ideally the loading conditions induced by the experimental apparatus should simulate those seen in actual aircraft wheel applications, such as landing or taxiing. With proper specimen design, the Krouse 200 in-lb rotating cantilever beam machine at Ohio State is capable of producing the alternating tensile and compressive stresses developed in these applications. With the rotary cantilever machine, the specimens undergo a constant rotational speed where the maximum stresses are found on the surface. A digital photo and a detailed schematic of the Krouse machine can be seen in Figures 14 and 15.

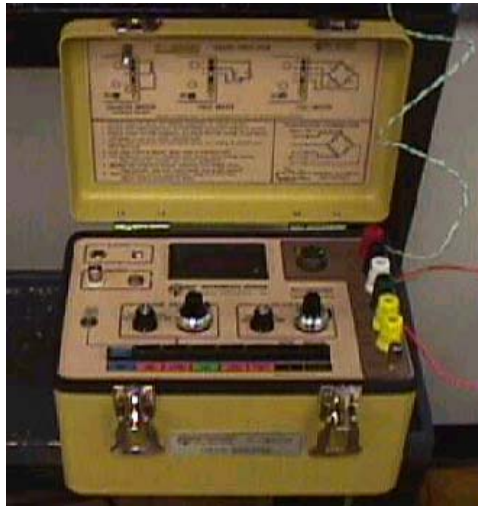
Figure 17: P3500 strain indicator used to calibrate Krouse machines

7050 T-74 specimens. To find the maximum tensile strain, the specimen was loaded with an arbitrary moment and manually rotated until a maximum value was read on a P3500 Measurements Group Incorporated strain indicator. A digital photo of the strain indicator is given in Figure 17.
